Mound-George IV Bridge-Lauriston Place bus stop audit report

The audit was undertaken by four EBUG Committee members on the morning of Friday 30 April, between the Foot of the Mound and Lauriston Place (Chalmers Hospital), comprising six 'outbound' and four 'city-bound' stops. Nine criteria were assessed for each stop, encompassing location, pavement widths (in relation to the *Edinburgh Street Design Guidance*, see Appendix 1), shelter condition, signage and lining, etc.

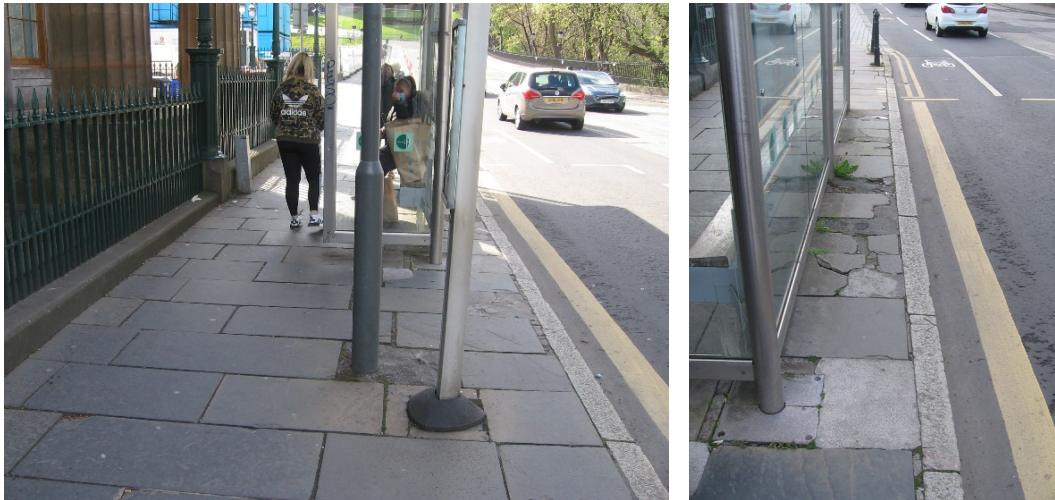
i. Outbound / Foot of the Mound / identity (ID) ‘MD’

This stop is generally satisfactory, but the Clear Walking Zone is only 1.36m and the pavement width 2.98m. The pavement is in poor condition immediately beside the kerb.

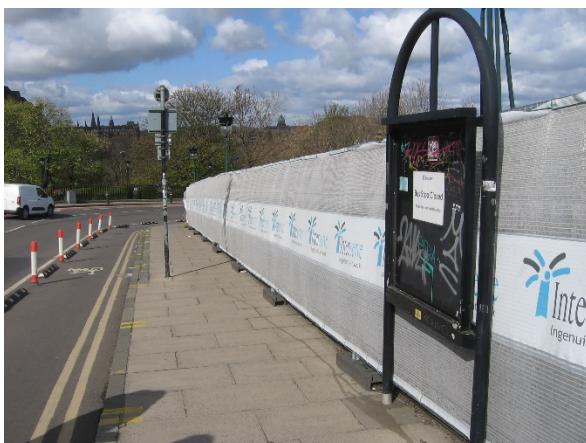
ii. Outbound / The Mound North of Market St junction / missing (suspended) stop

This stop was taken out of use as part of the SfP programme – in order to create a cycle lane – and consequently leaves a gap of 500m between current stops. It was a useful stop for the

high-density business / residential area immediately to the south, and for passengers from Waverley Station wishing to join Lothian Bus services 23, 27, 41, 42 and 67.

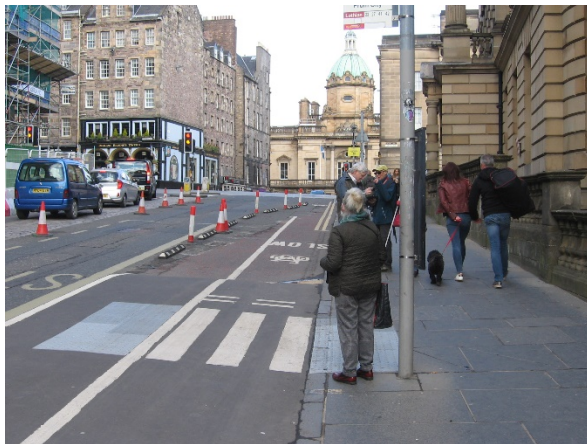
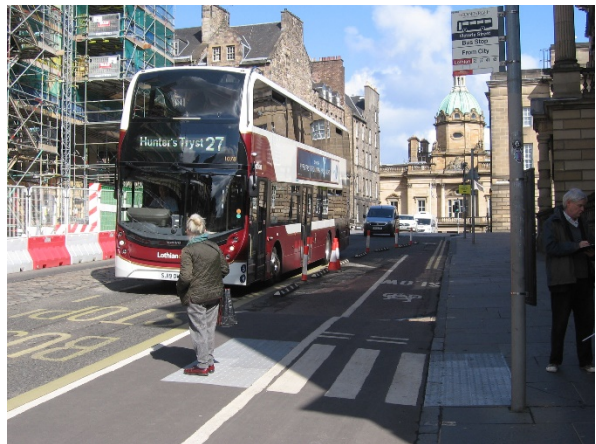
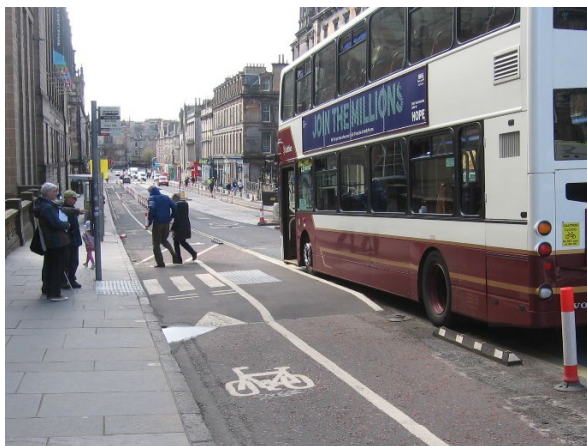
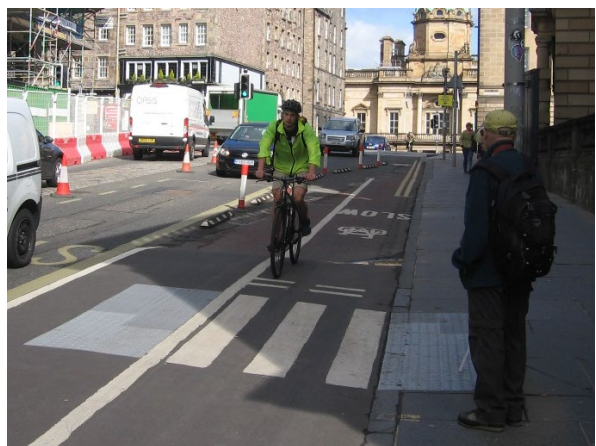
iii. Outbound / George IV Bridge at Victoria Street / ID 206380 (temporary stop)

This 'floating bus stop' was created under the SfP Programme, closing a permanent stop with a shelter beside the carriageway, and replacing it with a narrow bus 'island' separated from the pavement by a temporary cycle lane, and with no shelter. This is inconvenient and potentially dangerous for bus users – and demonstrably does not prioritise people on foot, despite the Council policy that 'Pedestrians are at the top of the urban transport hierarchy'.

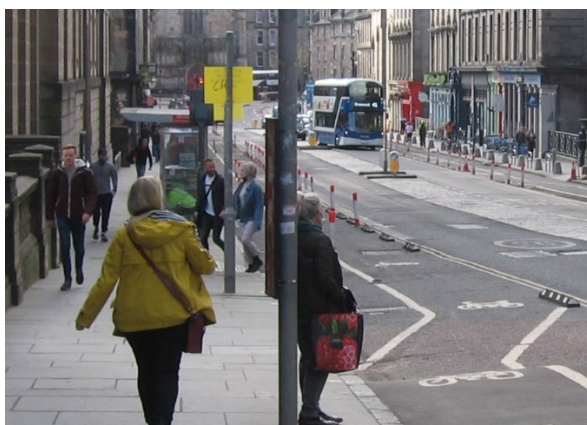
iv. Outbound / George IV Bridge at Victoria St / missing (suspended) stop

Suspended stop in middle distance

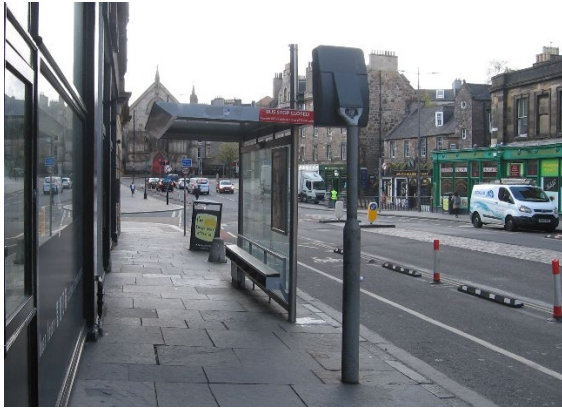
v. Outbound / George IV Bridge at Chambers St / missing (suspended) stop

This stop was taken out of use as part of the SfP programme, and leaves a gap between stops in excess of 400m in a very busy area for residents, shoppers and tourists.

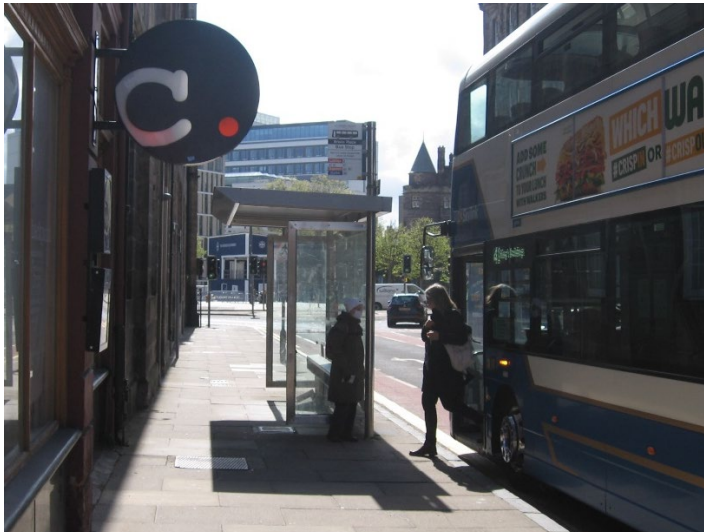
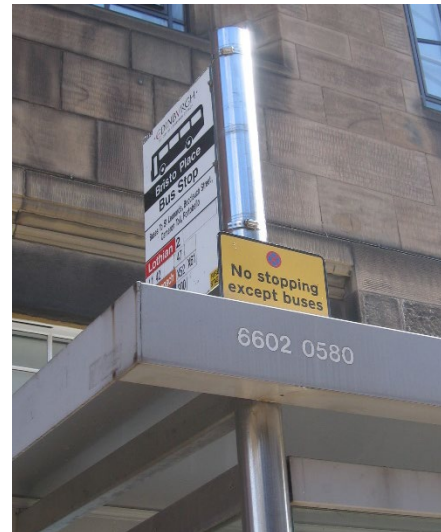
vi. Outbound / Bristo Place / ID 206420

This stop has not been well maintained, and the CWZ is only 1.85m (v. 'preferred' 2m) and the pavement itself just 2.85m wide (v. the 'general minimum' of 3m).

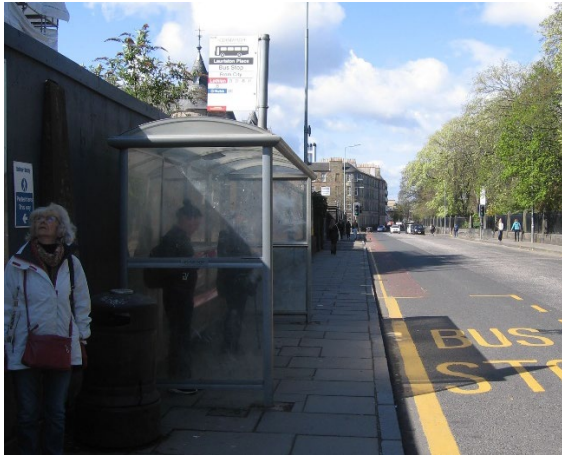
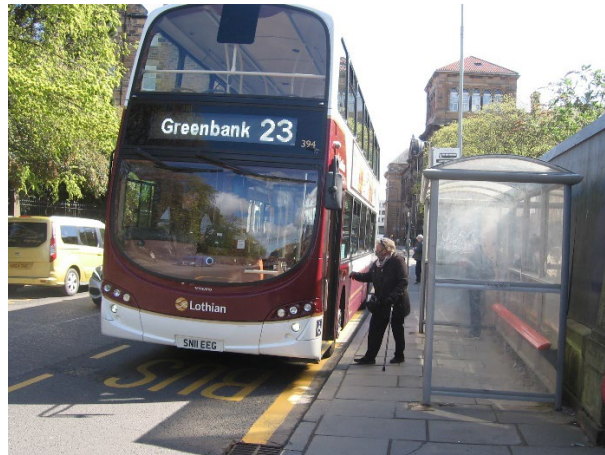
vii. Outbound / Lauriston Place west of Forrest Rd junction / ID 243720

The layout at this stop jumbles together bus passengers and passing pedestrians in a CWZ of only 1m, on a pavement just 2.34m wide (v. the 'general minimum' of 3m). The bus shelter is damaged and dirty.

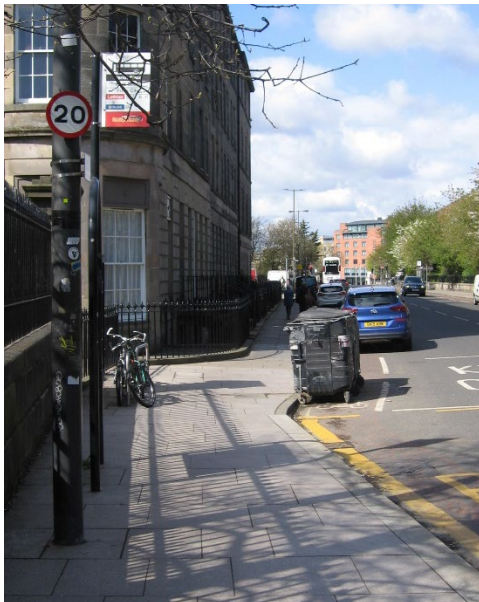
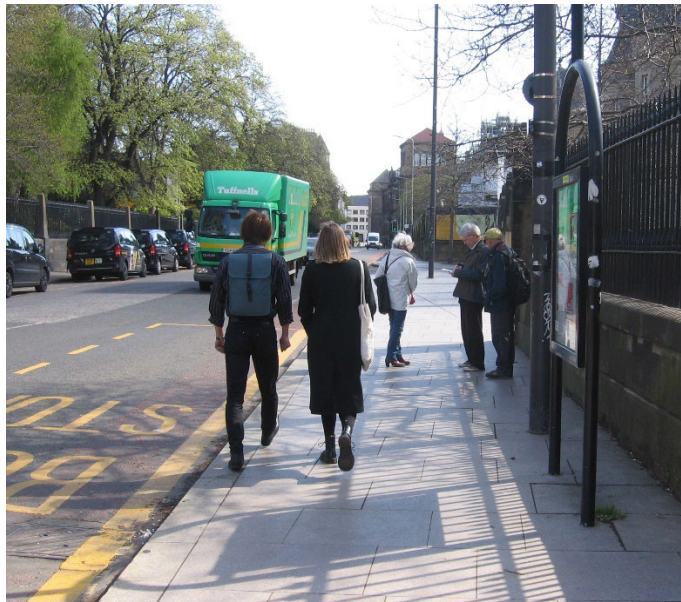
viii. Outbound / Lauriston Place at Heriot Place / ID 243730

There is no shelter here, and the length of 'upstream' yellow lining is insufficient – if cars are parked – to allow double-door buses to pull in fully parallel to the kerb.

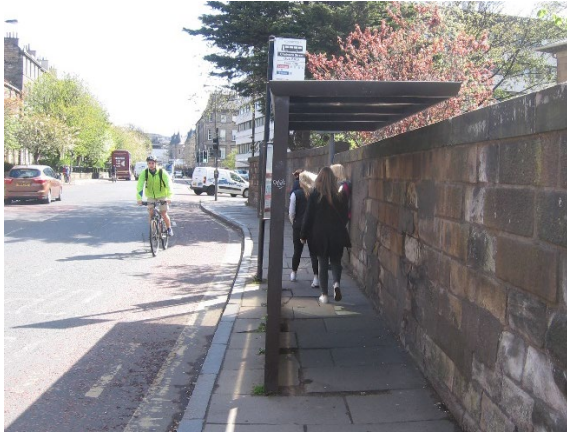
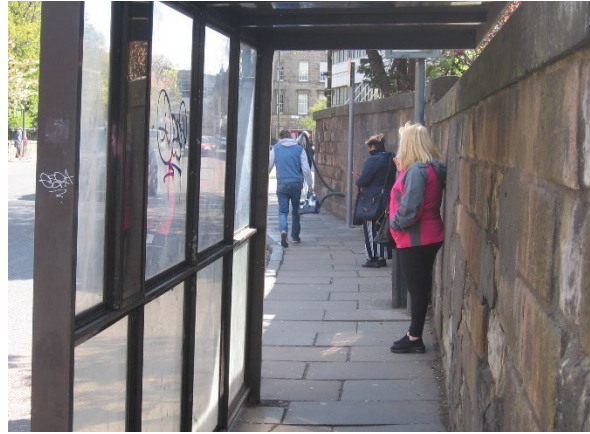
ix. Outbound / Lauriston Place at Heriot Place / ID 243730

This was the worst of the permanent bus stops audited. The pavement is extremely narrow – only 1.65m (v. the SDG ‘absolute minimum’ of 2m) – waiting bus passengers are jumbled up with passing pedestrians, the shelter has graffiti, and the yellow lining is poorly-maintained and of insufficient ‘upstream’ length to stop parked cars preventing double-doored buses from pulling in fully parallel to the kerb.

The spacing of outbound bus stops on Lauriston Place is poor, including a gap of more than 400m between this stop and the next at Home Street. This gap should be addressed as part of a review of the three current stops on Lauriston Place.

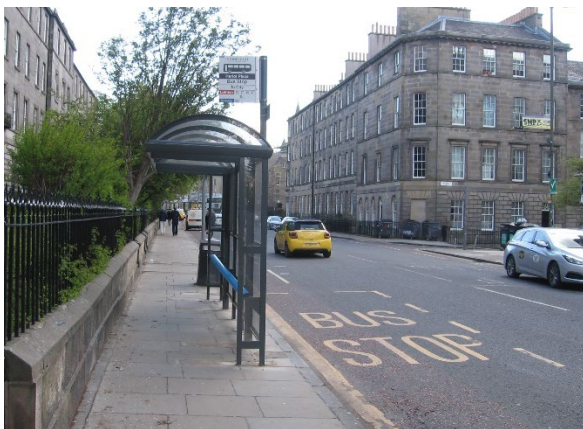
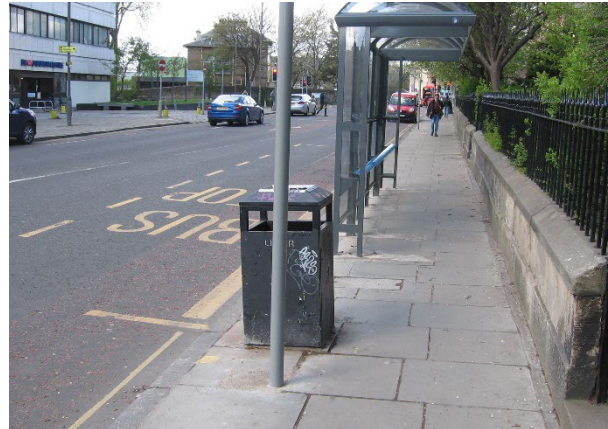
x. City-bound / Lauriston Place east of Keir St / ID 206160

The CWZ width here is only 1.2m and the pavement just 2m (v. the SDG ‘absolute minimum’ of 2m).

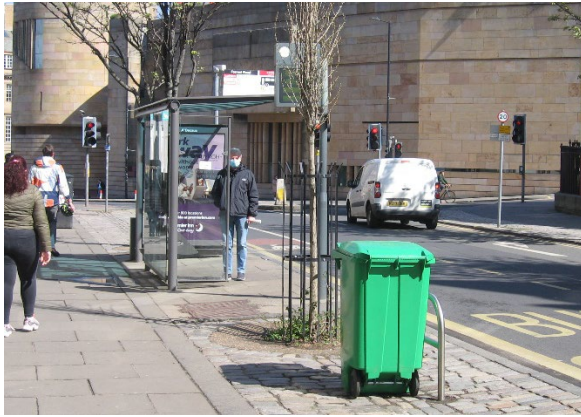
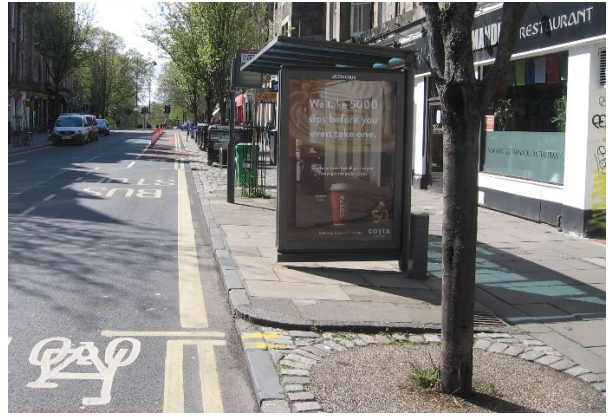
xi. City-bound / Forrest Rd / ID 24349

This was the best of the permanent stops audited in terms of location, pavement width, shelter maintenance, signage and lining, etc – but suffers from the generic flaws of the JC Decaux shelter, ie inadequate protection from wind and rain, close exposure to passing vehicles (and splashing water), cold and hard seating, and confusing queuing arrangements.

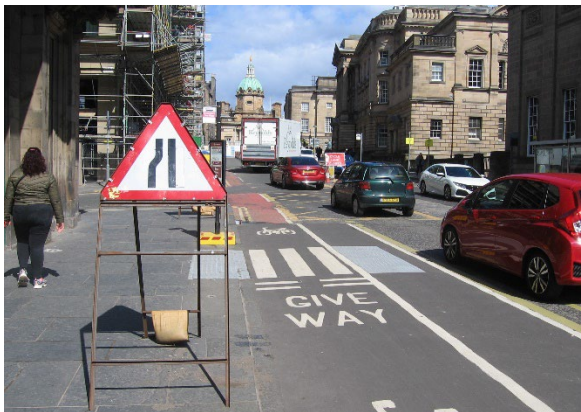
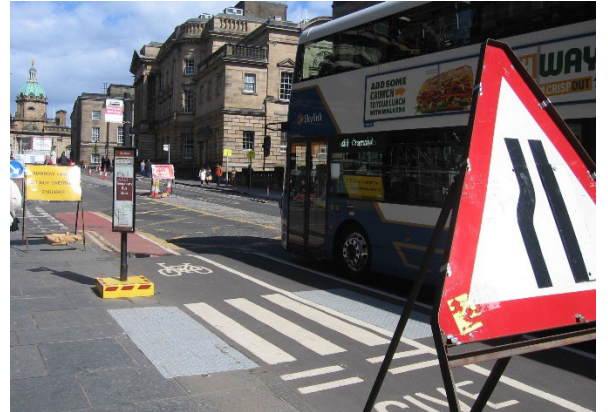
xii. City-bound / George IV Bridge at Victoria Street / ID 206380 (temporary stop)

This temporary 'floating bus stop' – created through the SfP programme in order to allow a cycle lane to be provided – has replaced a permanent stop at virtually the same location. There is no longer a shelter, and bus passengers have to cross the cycle lane to a narrow bus 'island'. This is both inconvenient and potentially dangerous.

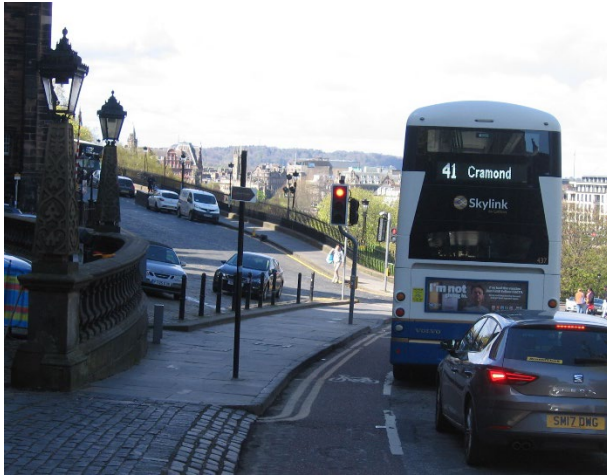
xiii. City-bound / North Bank St / missing (suspended) stop

This stop was taken out of use as part of the SfP programme, and consequently leaves a gap of 500m between current stops. It was a useful stop for the high-density business / residential area immediately to the south, and for passengers for Waverley Station using Lothian Bus services 23, 27, 41, 42 and 67.

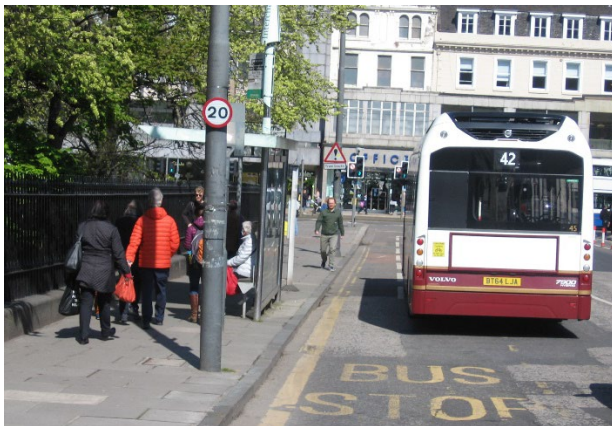
xiv. City-bound / Foot of the Mound / ID 243575

This is an important interchange point for Princes St buses (albeit too far from Princes St due to junction constraints) but the pavement is too narrow and congested for such a key location – only 3m (v. the ‘desirable minimum’ width of 5m or more).
