Flooding problems at newly laid Melville Crescent to be fixed “as soon as possible”

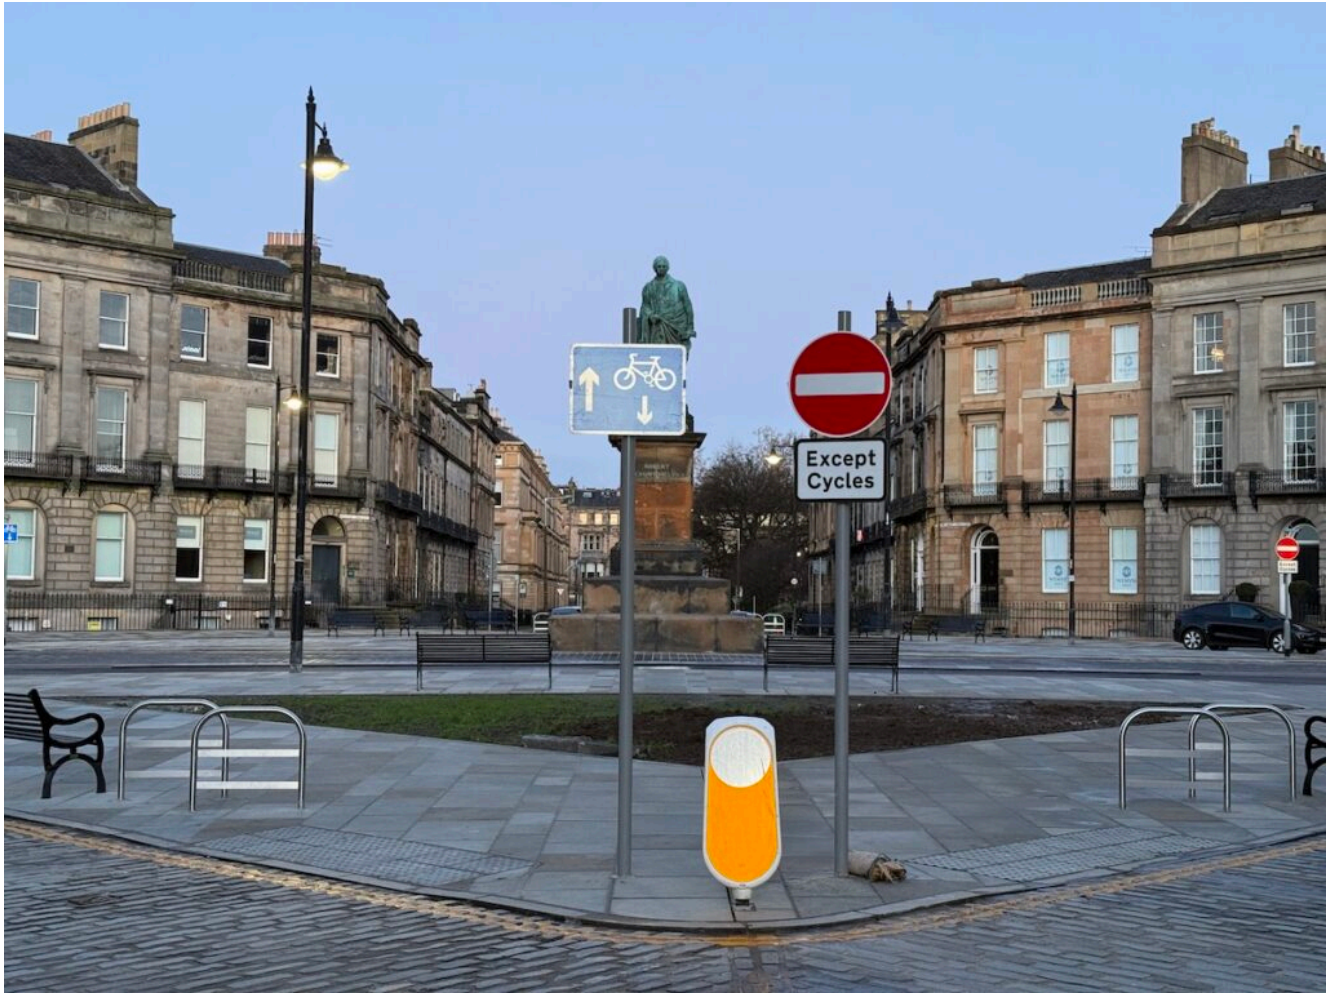
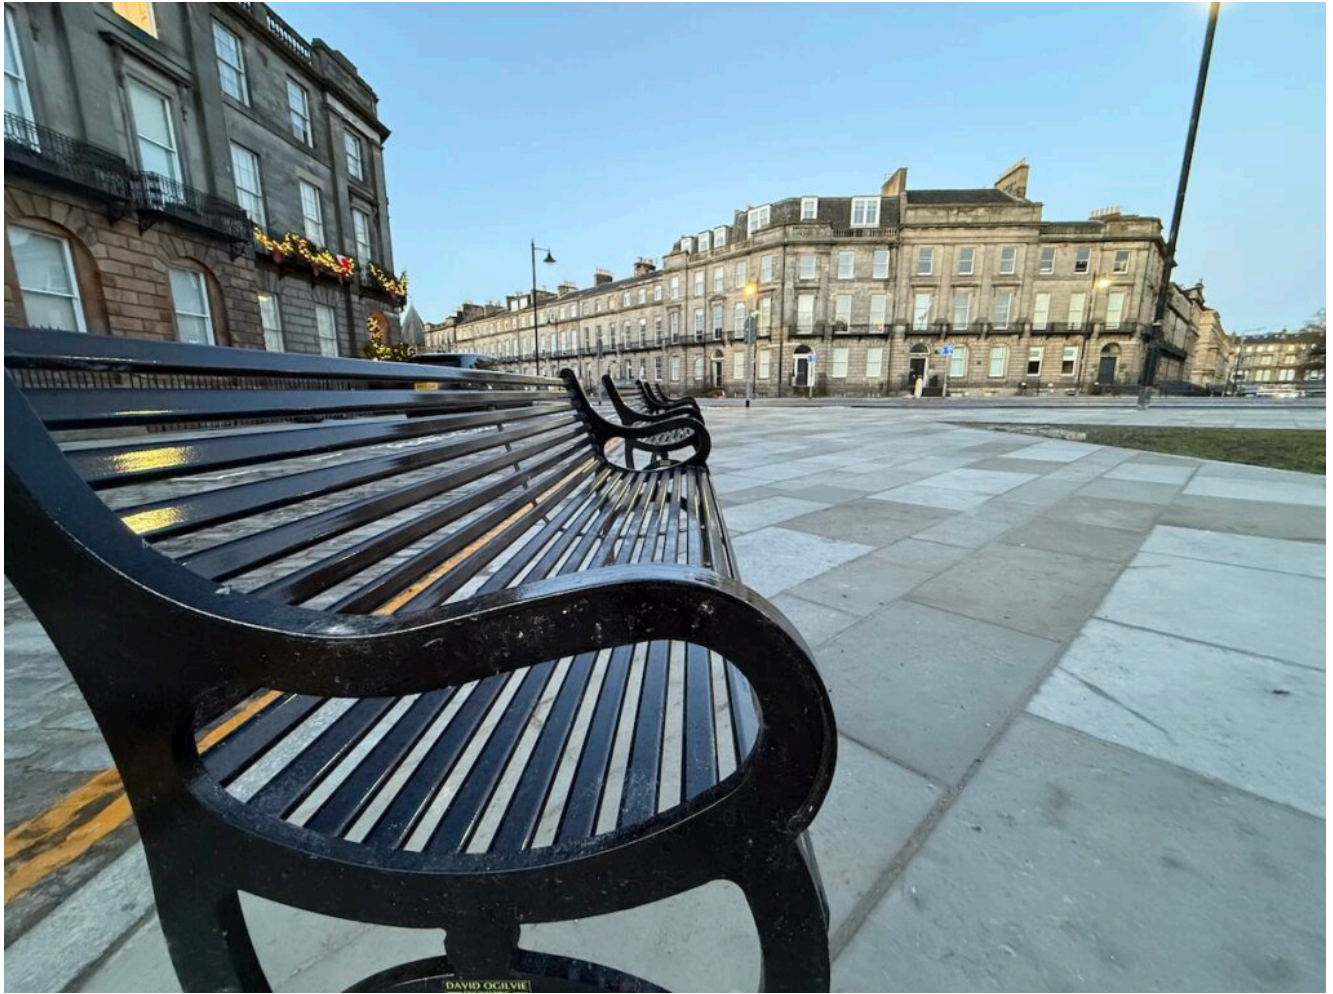
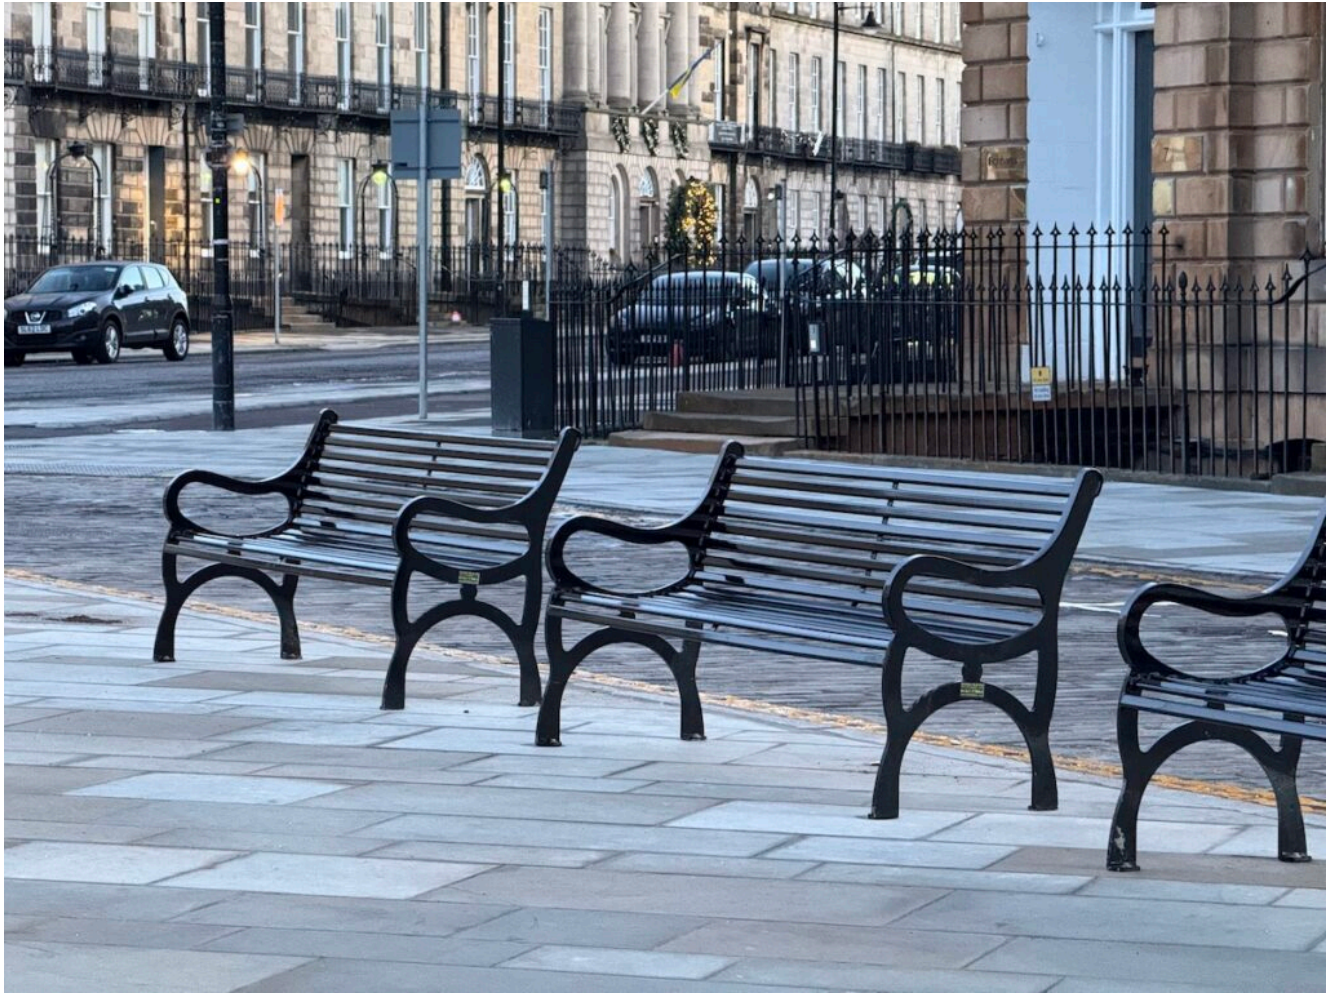
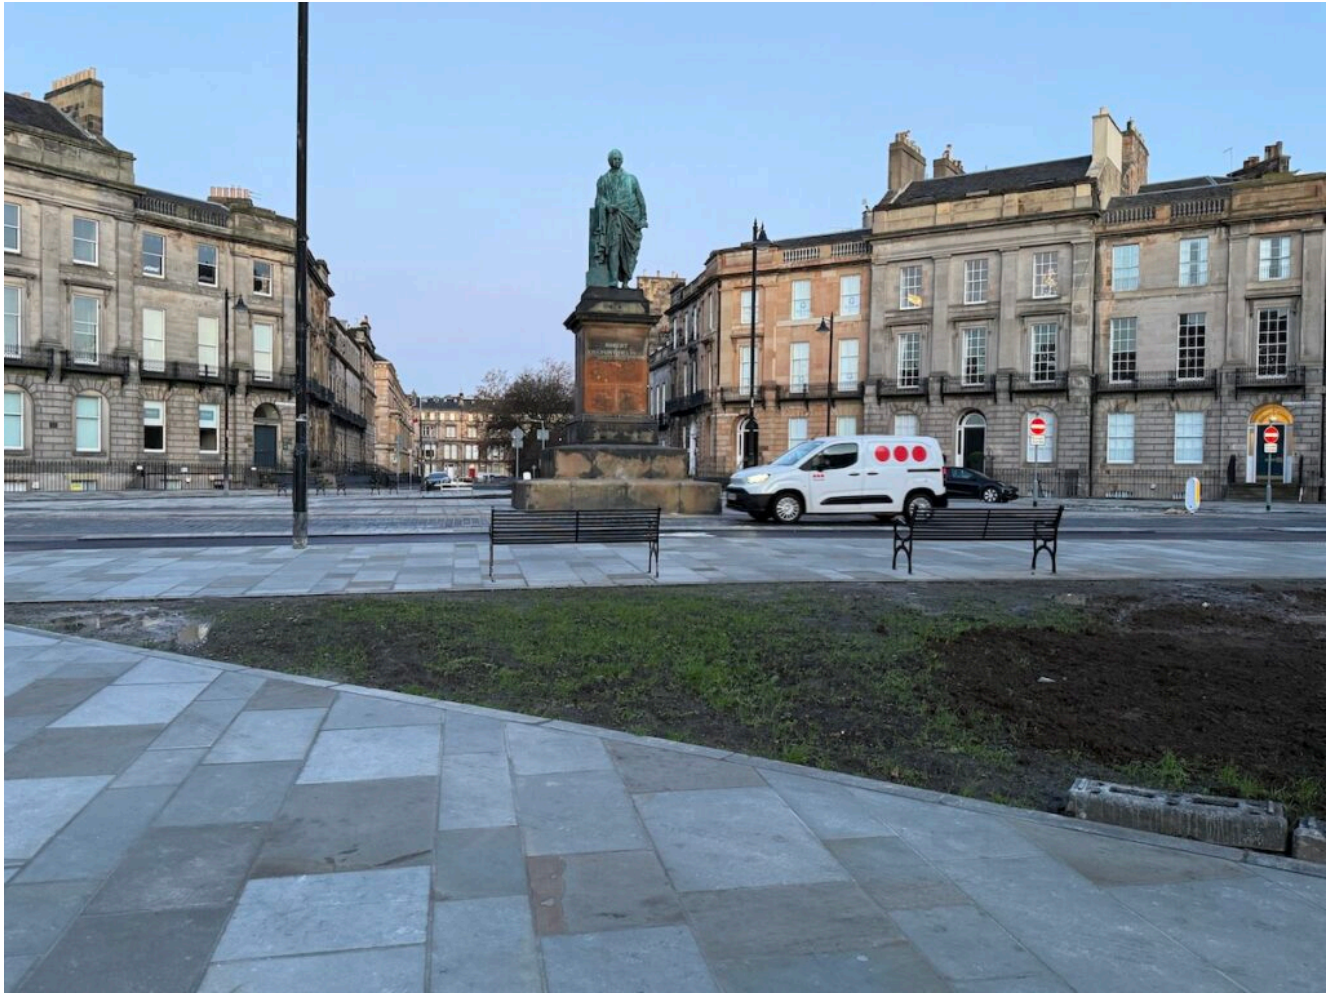
At New Year however it was another story with flooding evident on the newly formed street and some basement owners fearing their properties would be flooded. Then, after the water had apparently been cleared by the council’s gully team, it happened again on 5 January.

[@cllr_jenkinson](#) [@Edinburgh_CC](#) [@balfourbeatty](#) [@jomowat](#) [@edinwestendcc](#) [@BenMacpherson](#) 2 days ago many of us called for emergency drain clearing of the £2.1m works at Melville Crescent (pic 1) The situation is worse tonight (pic 2) Investigate please! Properties are at risk ! pic.twitter.com/c8EHELduIt

Balfour Beatty, the contractors behind the City Centre to West Edinburgh Link (CCWEL) and the reimagining of Melville Crescent were contacted for comment. A spokesperson said: *“We are aware of the drainage issues at Melville Crescent. Following a CCTV inspection earlier this week, a partial blockage was identified in the drainage line that our system connects to.*

“Whilst there is currently no flooding at the location, we have appointed a drainage specialist to investigate the cause of the blockage and are awaiting their proposal to rectify the issue. Once received, we will clear the blockage as soon as possible.”
