Flooding problems at newly laid Melville Crescent to be fixed “as soon as possible”

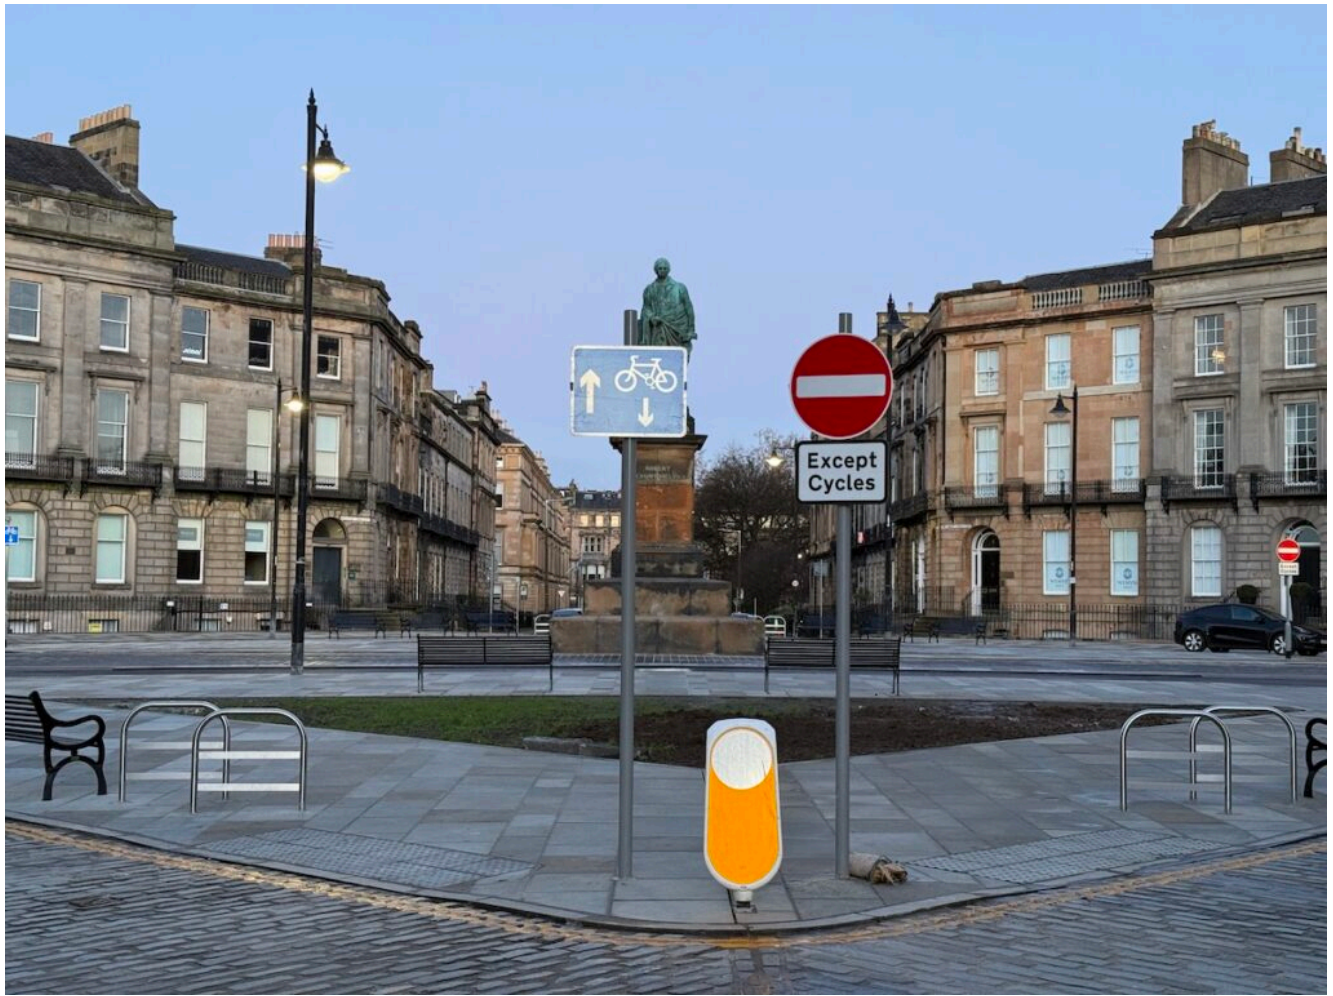
At New Year however it was another story with flooding evident on the newly formed street and some basement owners fearing their properties would be flooded. Then, after the water had apparently been cleared by the council's gully team, it happened again on 5 January.

[@cllr_jenkinson](#) [@Edinburgh_CC](#) [@balfourbeatty](#) [@jomowat](#) [@edinwestendcc](#) [@BenMacpherson](#) 2 days ago many of us called for emergency drain clearing of the £2.1m works at Melville Crescent (pic 1) The situation is worse tonight (pic 2) Investigate please! Properties are at risk ! pic.twitter.com/c8EHELduIt

Transport and Environment Convener, Councillor Stephen Jenkinson told The Edinburgh Reporter: “We are aware of the issues with drainage on Melville Street and damaged paving at the junction of Stafford Street. We are continuing to work with our contractor to identify the cause of the drainage

Balfour Beatty, the contractors behind the City Centre to West Edinburgh Link (CCWEL) and the reimagining of Melville Crescent were contacted for comment. A spokesperson said: *“We are aware of the drainage issues at Melville Crescent. Following a CCTV inspection earlier this week, a partial blockage was identified in the drainage line that our system connects to.*

The contractor also went on to say that the paving had been laid in accordance with specifications. Residents have raised the matter of broken paving slabs at the end of Stafford Street.

issue. Remedial works to the damaged paving are scheduled to be carried out by our contractor next month.”

“Whilst there is currently no flooding at the location, we have appointed a drainage specialist to investigate the cause of the blockage and are awaiting their proposal to rectify the issue. Once received, we will clear the blockage as soon as possible.”
