LNER – update on East Coast services

We have received the following Service Update from LNER on Wednesday morning following the discovery of cracks in a few of the Class 800 Series Hitachi trains – the Azuma.

What is a lifting point?

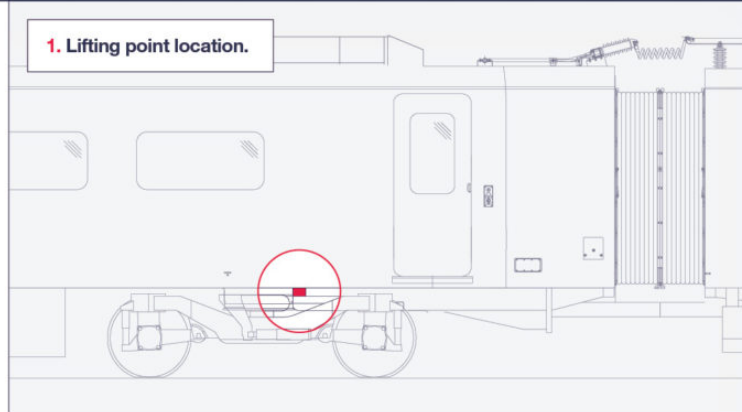
1. Lifting point location.

On 8th May, maintenance teams identified small cracks under the train carriages on the lifting points.

The lifting points are not used as part of the normal train operation; their purpose is to allow the train to be lifted up in depots for maintenance.

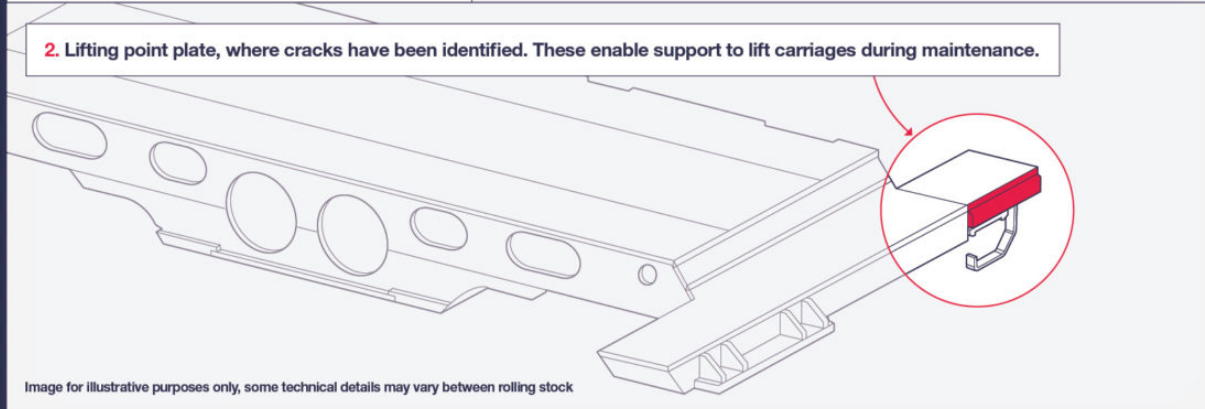
2. Lifting point plate, where cracks have been identified. These enable support to lift carriages during maintenance.

“All trains continue to be thoroughly inspected daily before they leave the depot. Trains will only re-enter service if they meet agreed safety criteria, and this includes a small number of trains that have been found to have cracks where the yaw damper connects to the bolster bracket.

“Over time, trains will be subject to a Forward Repair Plan, which will ensure the long-term continued safe running of the fleet.”
